## Clinical Case 1 – Perforation repair: A case of repair of pulpal floor perforation caused by excessive cutting of the floor of the pulp chamber

**Introduction to the case:** pulpal floor perforation caused by excessive cutting of the floor of the pulp chamber.

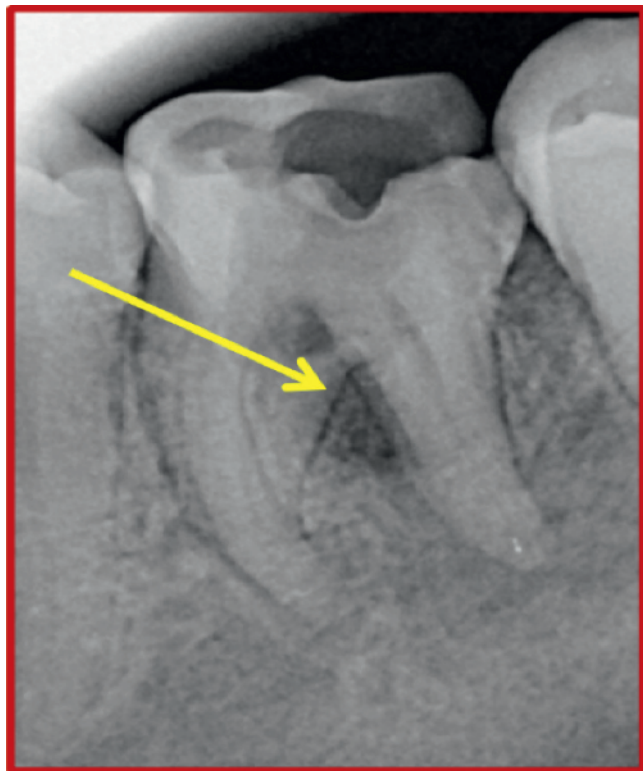
**Figure 1.1** Preoperative radiograph showing radiolucency in the furcation area.

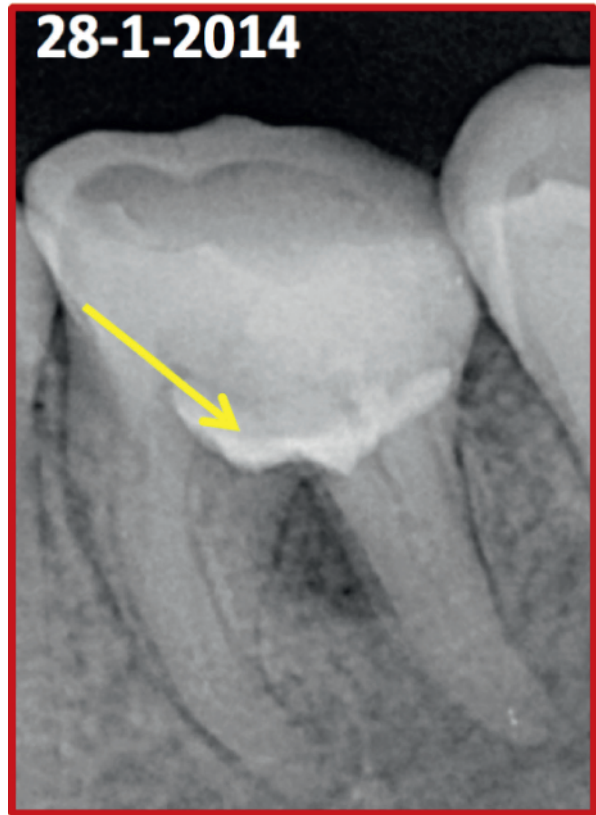
**Figure 1.3** Radiograph showing MTA placed on the pulpal floor.

- *First visit:* local anaesthesia, rubber dam isolation, magnification (dental operative microscope), conventional access cavity, identification of orifices of the canals, placing cotton pellets inside them, stopping the bleeding physically with cotton pellet (Figure 1.2).
- *Treatment plan for management of the endodontic mishap:* applying MTA at the furcation area, then inserting a wet cotton pellet over MTA, temporary filling (Figure 1.3).

- Stop bleeding before applying MTA.
- Place wet cotton pellet over MTA and wait at least 4 hours to let it set.

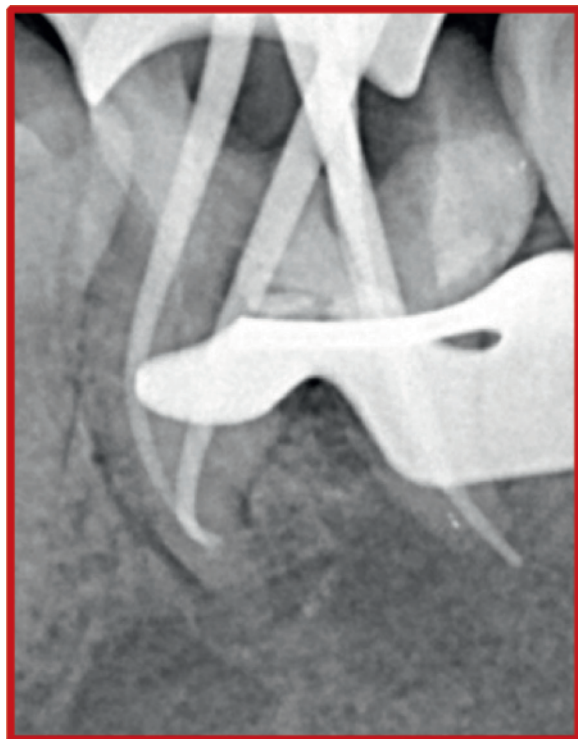
**Figure 1.4** Radiograph showing master cone verification after biomechanical preparation of root canals.

- *Second visit:* removing temporary filling and cotton pellets, Check the condition of MTA (hardness), canal preparation with rotary files.
- *Irrigation protocol (solution and technique):* 5.25% NaOCl; passive sonic irrigation.
- *Final irrigation protocol:* 17% EDTA (syringe irrigation) for 1 minute.
- *Obturation (materials and technique):* zinc oxide-based sealer (Sealite™ Ultra) and gutta-percha; warm vertical compaction.
- Permanent filling (Figures 1.4 and 1.5).

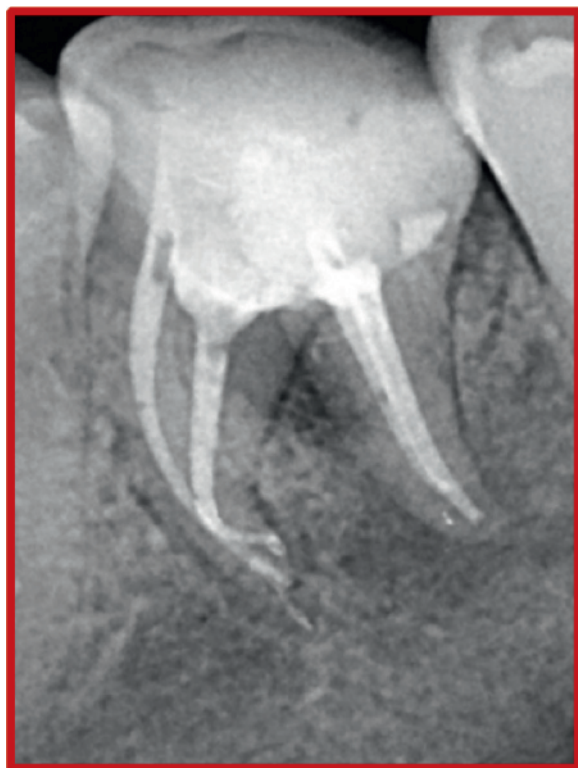
**Figure 1.5** Radiograph showing obturation along with intact MTA.

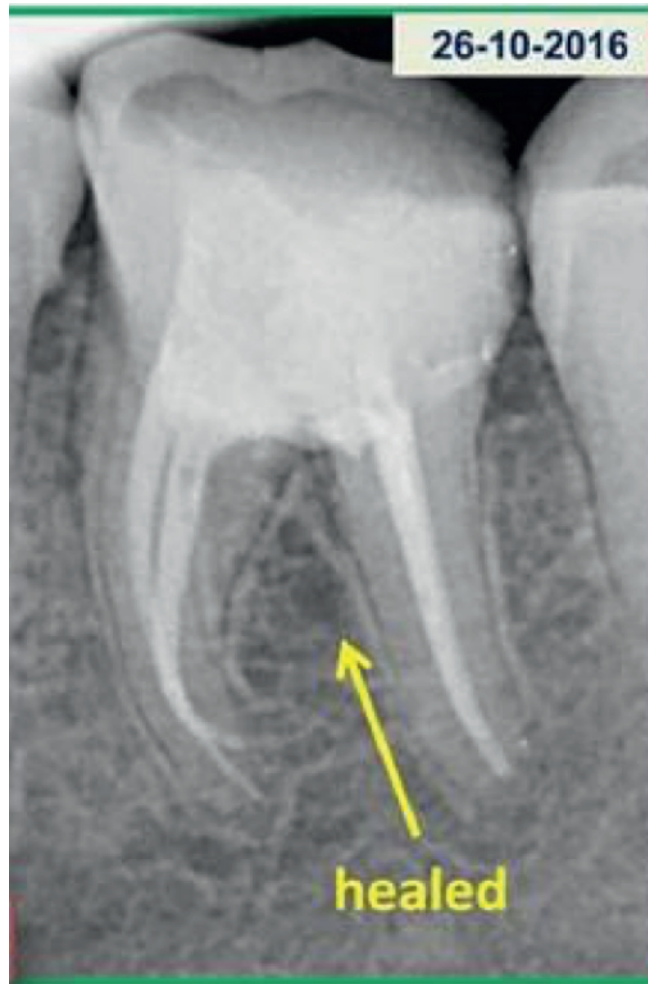
Follow for 2.5 years. The follow-up radiograph shows formation of a bony trabecular pattern. Clinical and radiographic healing is evident on follow-up visits (Figure 1.6).

**Figure 1.6** Follow-up radiograph showing healing in the furcation area.
